## **FINAL REPORT**

# **Broadband Electromagnetic Technology**

**DOT Prj# 258**

**Contract Number: DTPH56-08-T-000024**

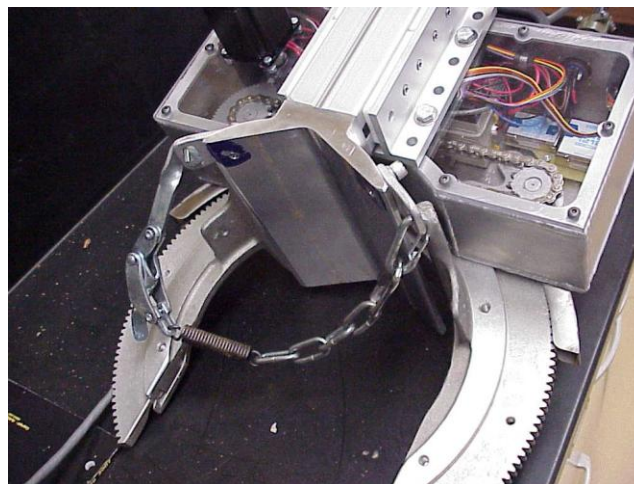
**Figure 3 – Modified FEU with Adjustable Centering**

GTI has made several enhancements to the full encirclement unit (FEU). The FEU is now, reversible allowing the pipe to be scanned in both directions. This is critical in keyhole applications where the FEU may need to be rotated 180 degrees in place in order to scan a larger area of the pipe through the keyhole excavation. The scan reversal allows all of the pipe data to be acquired in the same direction regardless of the orientation of the FEU head. Several modifications were made to seal the mechanism against the intrusion of water and dust. The FEU now has an adjustable foot to accommodate pipes of different diameters. Previously, this had been accomplished by having a set of spacers specific to each pipe diameter, shown in Figure 2. The new system, shown in Figure 3, uses a sliding adjustment, eliminating spacer change out.

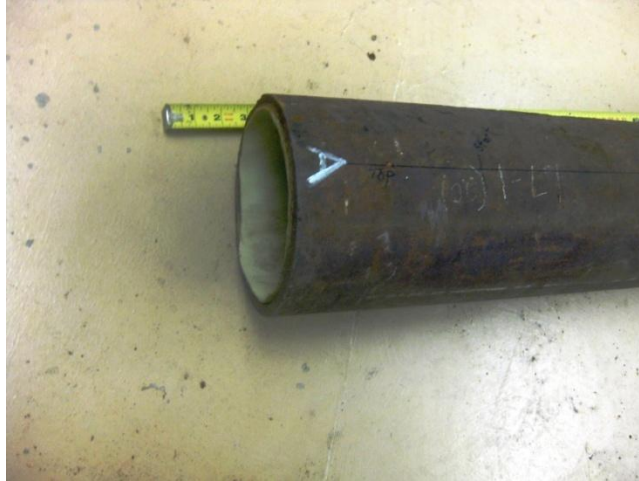
**Figure 6. Pipe A- Nodular (ductile) iron pipe with lining**

Nodular iron, also referred to as ductile iron, is a gray cast iron type that has been treated with a nodularizing agent so that all or the major portion of its graphitic carbon has a nodular form as cast. Pipes A (Figure 6), C (Figure 10), G (Figure 18) and H (Figure 20) are nodular (ductile) iron. This microstructure is illustrated in Figure 7, Figure 11, Figure 19, and Figure 21 for the pipe samples.

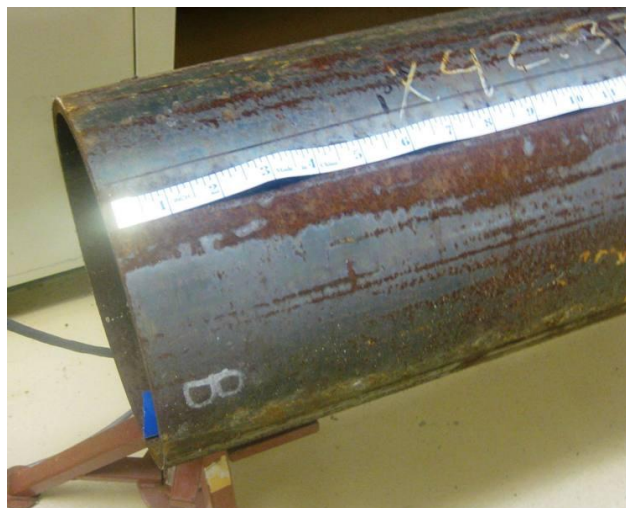
**Figure 8. Pipe B- Carbon Steel pipe**

Plain-carbon steel is a metal alloy, a combination of two elements, iron and carbon, where other elements are present in quantities too small to affect the properties. Pipes B (Figure 8), and I (Figure 22) are carbon steel. This microstructure is illustrated in Figure 9 and Figure 23 for the pipe samples. High strength low alloy (HSLA) steel is a type of alloy steel that provides better mechanical properties or greater resistance to corrosion than carbon steel. Pipe F (Figure 16) is HSLA steel. This microstructure is illustrated in Figure 17 for the pipe sample. HSLA steels vary from other steels in that they aren't made to meet a specific chemical composition, but rather to specific mechanical properties.

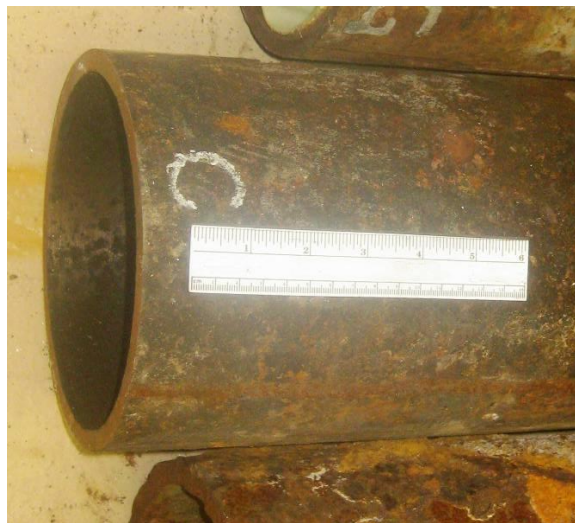
**Figure 10. Pipe C Nodular (ductile) iron**

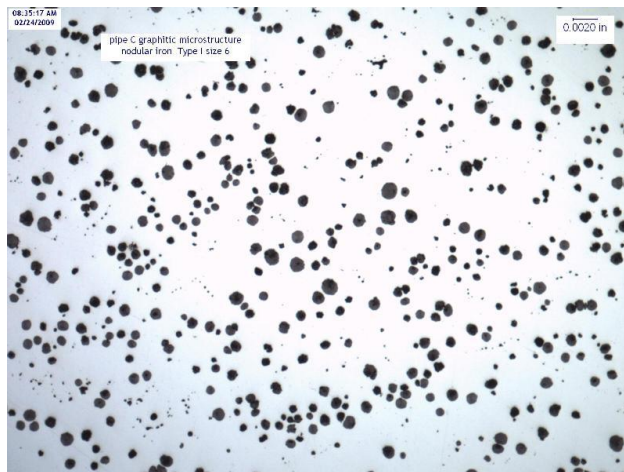
**Figure 11. Pipe C Nodular (ductile) iron Type 1 size 6**

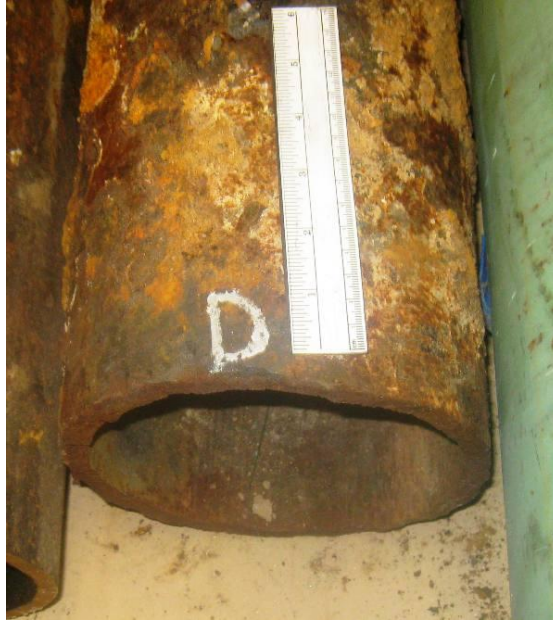
**Figure 12. Pipe D Gray Cast Iron pipe.**

Gray cast irons generally contain more than 2 percent silicon, and the carbon exists as flakes of graphite embedded in a combination of ferrite and pearlite. Pipes D (Figure 12), E (Figure 14) and J (Figure 24) are gray cast iron. This microstructure is illustrated in Figure 13, Figure 15, and Figure 25 for the pipe samples.

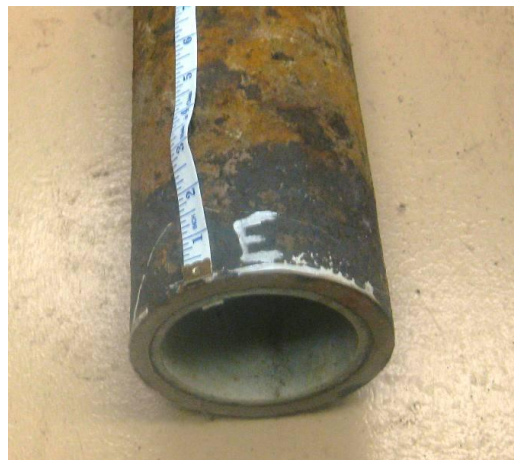
**Figure 14. Pipe E Gray cast iron with internal lining**

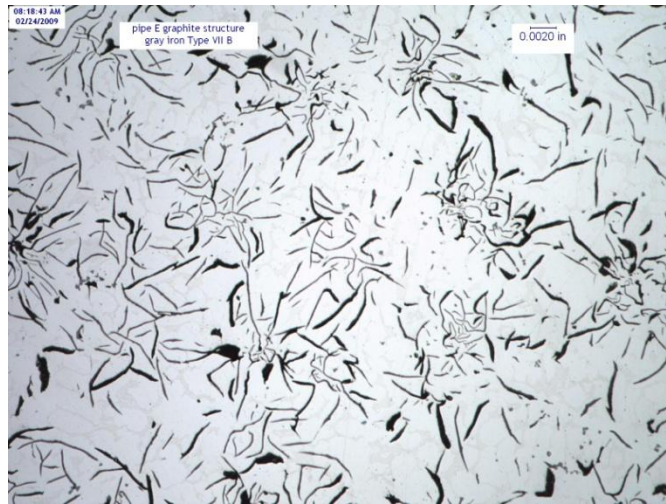
**Figure 15. Pipe E Gray cast iron Type VII B**

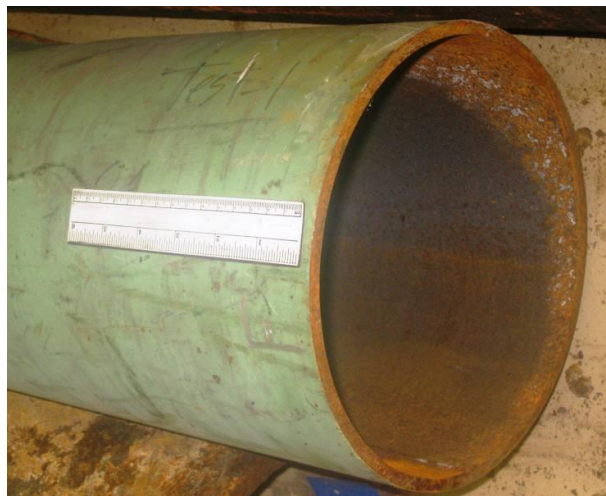
**Figure 16. Pipe F Coated HSLA steel**

Experiments involving multiple FEU scans per data file were carried out on pipe F. This pipe is .08C high strength low alloy steel with a length of 44 inches and ID 8 inches. Wall thickness varied from 0.264 inches to 0.274 inches measured at the ends. Measured from start end there is burst in the pipe from 22 to 31 inches. The pipe deformation around the burst precludes using the FEU over the entire length of the pipe.

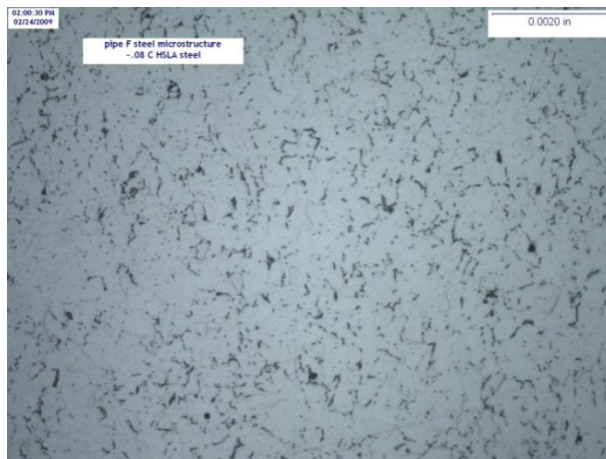
**Figure 17. Pipe F High strength low alloy steel (~0.08C)**

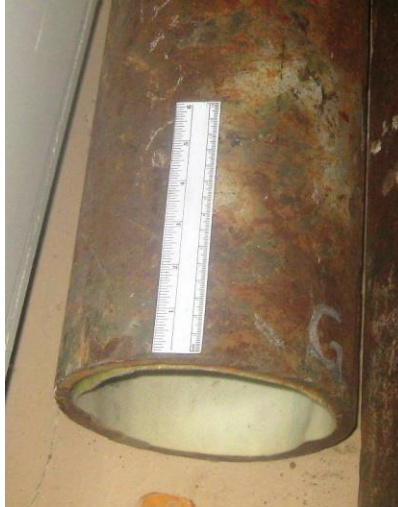
**Figure 18. Pipe G. Nodular (ductile) iron lined pipe**

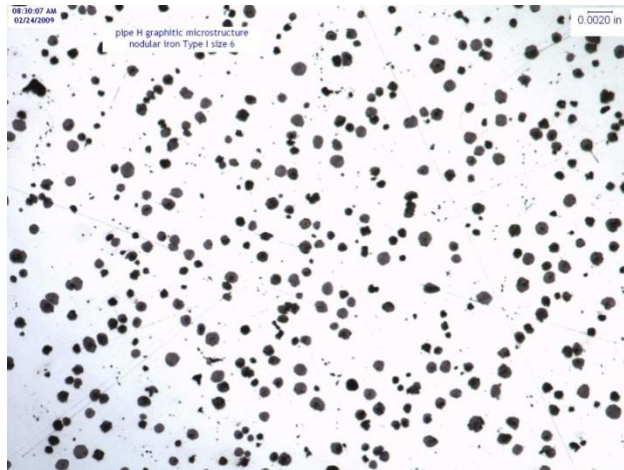
**Figure 21. Pipe H. Nodular (ductile) iron Type 1 size 6**

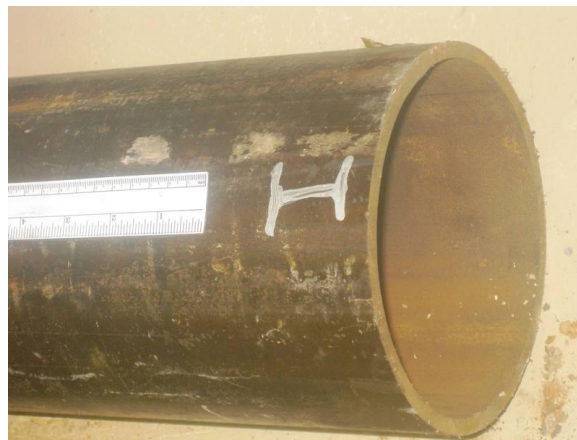
**Figure 22. Pipe I Carbon steel pipe**

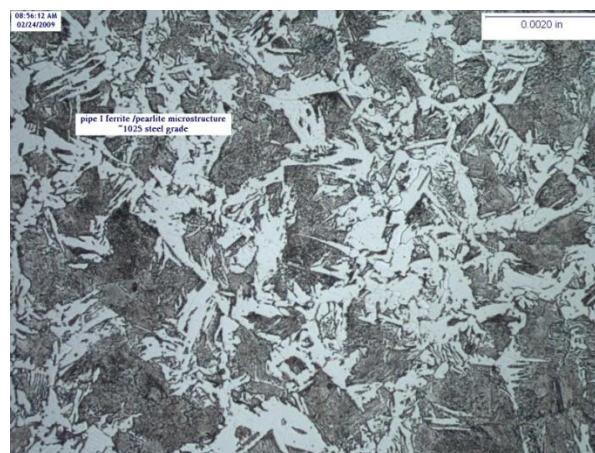
**Figure 23. Pipe I. Carbon steel (~1025 grade)**

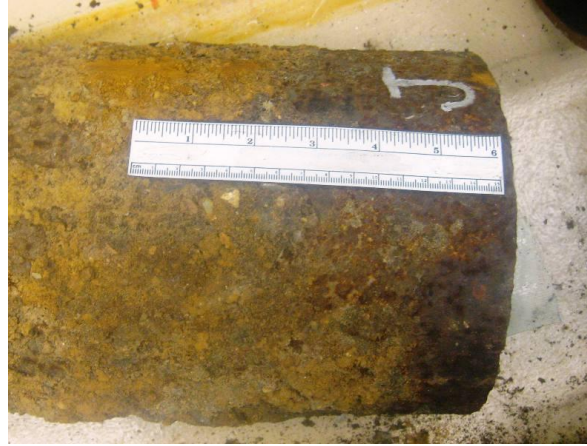
**Figure 24. Pipe J Gray cast iron Pipe.**

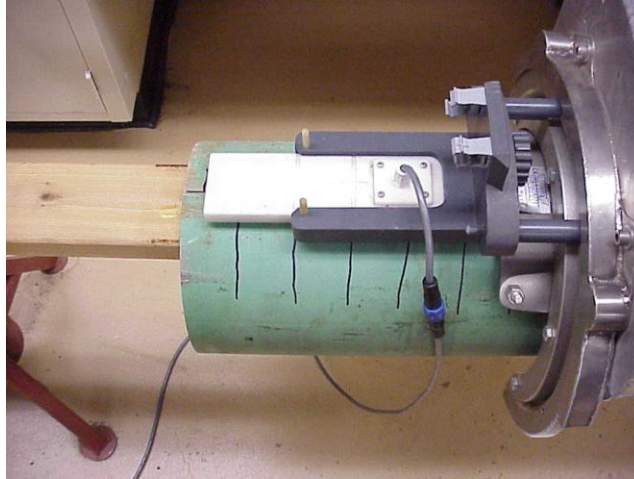
**Figure 35 - FEU moved to the next position on the pipe. Ring 3 is positioned at the 2<sup>nd</sup> mark from the left**

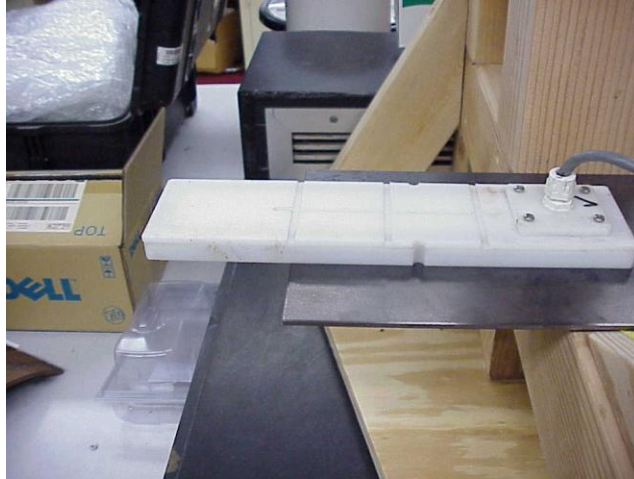
**Figure 40 – Three Antennae Sensor with antennae A and B on and C off the test plate**

As can be seen from the above experiments, the software that assembles the collected data into images implicitly assumes that the antenna is advanced with the cable and connector trailing. Failure to do this causes the “rings” of circumferential data to be improperly mapped into the processed image. The experiments were repeated with the three antennae sensor. The test plate was once again used to determine the correspondence of the three antennas in the antenna assembly to the columns in the display. For the three antenna module, antenna A is nearest the connector, B is in the middle and antenna C is the most distant from the connector.

It is demonstrated that unless care is taken in the set up and execution of multiple scans it is possible to map the image data incorrectly. Rather than the expected ordering ABCABC one can obtain CBACBA. Stripes of the processed image can be mirror images rather than correct.
